## Ghaggar Flood 2010 as viewed on July 19, 20 and 21, 2010

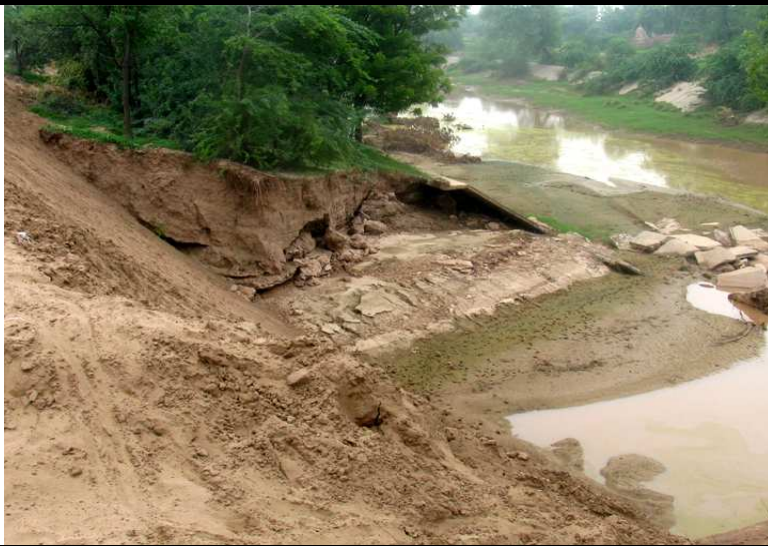
Breach on Sulej-Yamuna Link Canal near Bada Kammi Village in Patiala District of Punjab.

Breach occurred on July 8, 2010

Breach was plugged temporarily.

Water of Pachhisdhara, a tributary of River Ghaggar, entered into Sulej-Yamuna Link Canal through the breach.

SYL canal viewed in the right hand side.

Photograph taken on July 19,2010

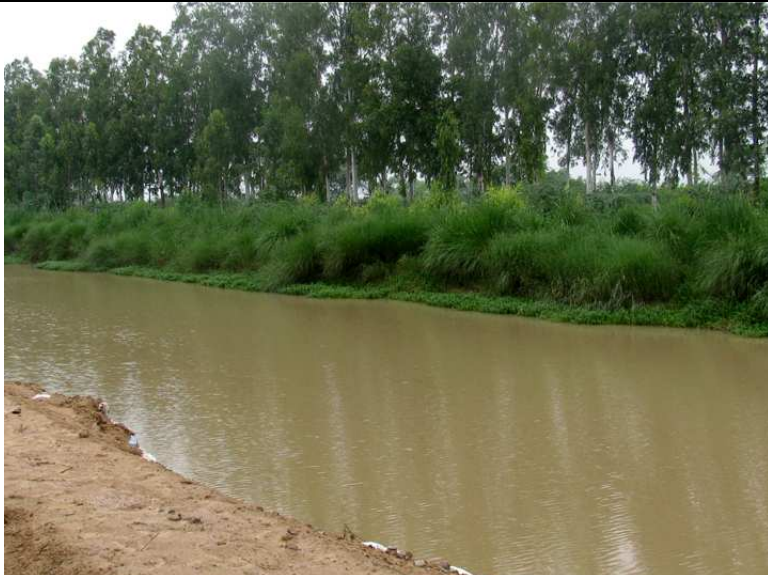
SYL Canal near breach site at Jyotisar, Kurukshetra.

Note level of water (the canal is not suppose to carry any water) and its poor maintenance.

Photographed on July 20, 2010

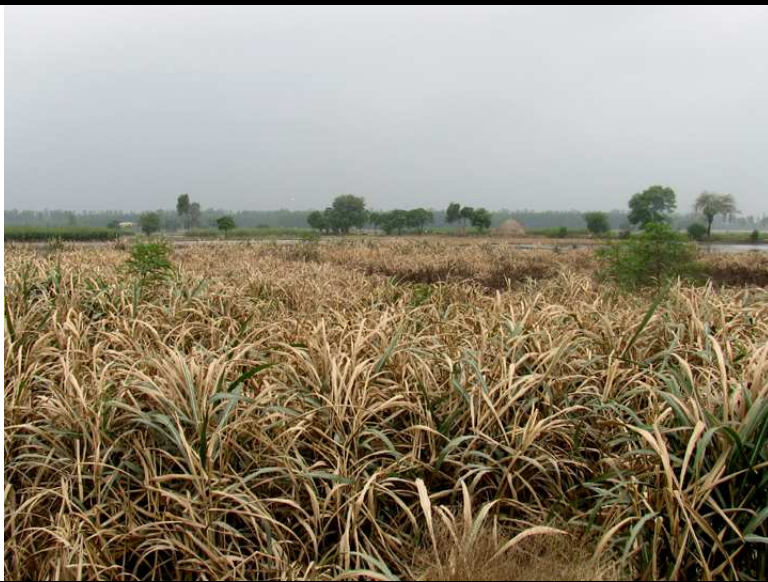
Crop loss due to breach of Sulej-Yamuna Link Canal near Jyotisar, Kurukshetra, Hariyana on July 6, 2010.

Photograph taken on July 20, 2010

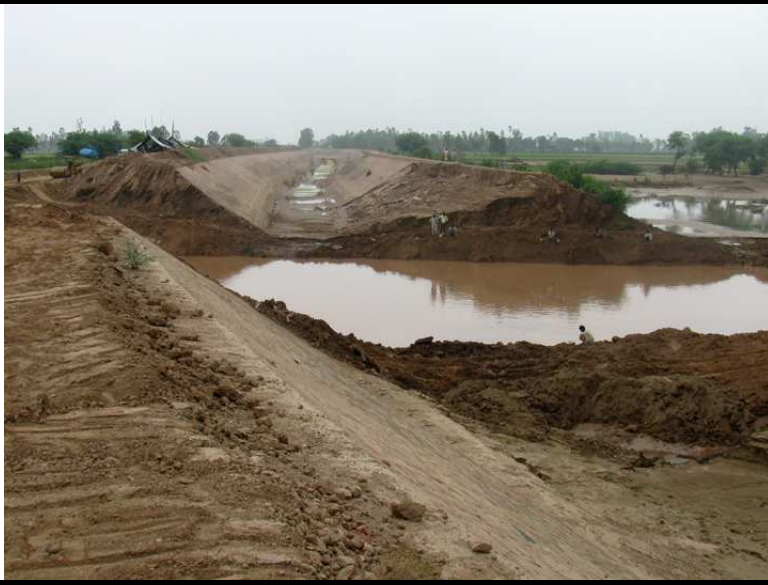
Breach on Hansi Butana Canal near Tatiana village, Kaithal District of Haryana on the midnight of July 7, 2010. Ghaggar water breached the Left bank of the canal and then breached the opposite bank also.  
Note the complete breakdown of the canal structure. River water enters from the left hand side and passes through right hand side.  
Photographed on July 21, 2010

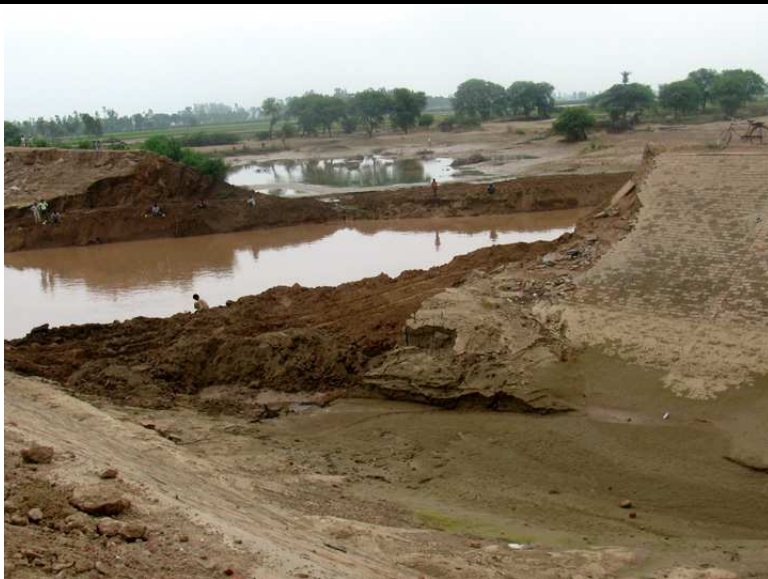
Right bank of Hansi Butana Canal and flooded plain

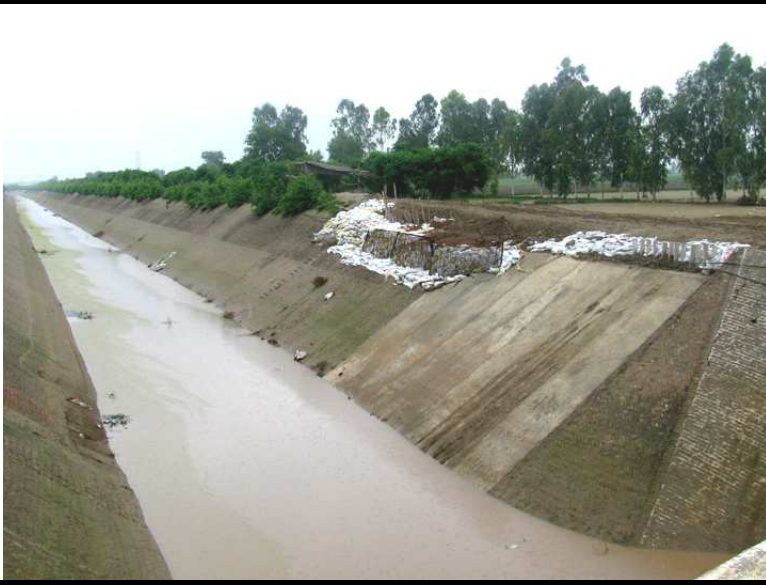
Breach on the right bank of the Hansi Butana Canal near Keorak village in Kaithal District of Haryana. Breach occurred on July 9, 2010. Temporary plugging is noticed. Photograph taken on July 20, 2010

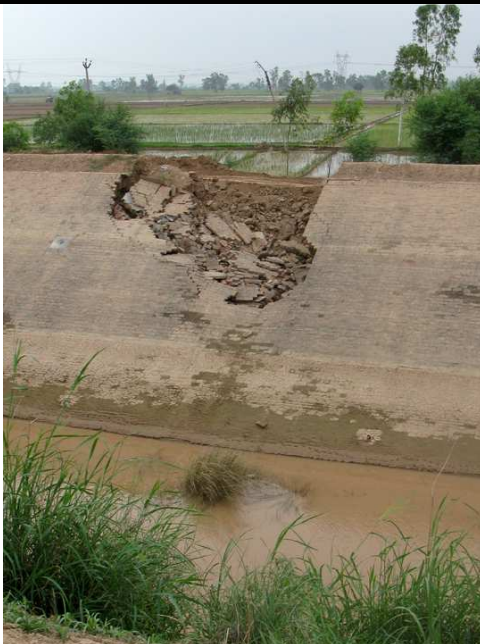
Another breach near Keorak on Hansi Butana Canal. Photograph taken on July 20, 2010.
